Use of biocompatible materials for enhanced aesthetics and soft tissue stability after implant treatment

Fabrice Baudot examines how a challenging case to achieve an aesthetic outcome in can still be successful as long as the patient is satisfied

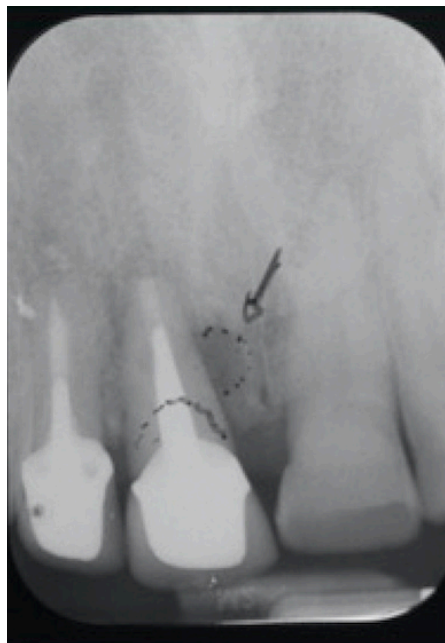
Figure 1: Initial radiograph

The tooth was black and non-vital, with a longitudinal fracture on the root (Figure 1) so extraction was indicated. A flap was opened (Figure 2) to reveal significant bone loss. With such a huge bone defect in the aesthetic region, the challenge was to provide an aesthetically acceptable restoration.

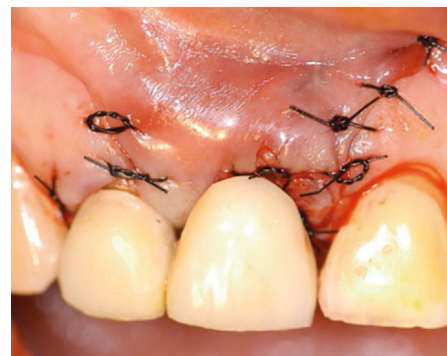
Figure 5: Surgical site – immediately postoperative

High quality soft tissue incisions are vital for an aesthetic finish when suturing the tissue closed after surgery, as shown in the

immediate postoperative photo (Figure 5) and the image from eight days later (Figure 6).

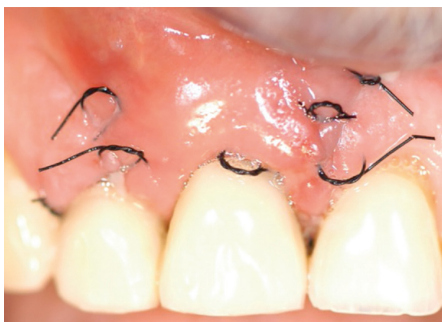
Figure 6: Surgical site – eight days postoperative

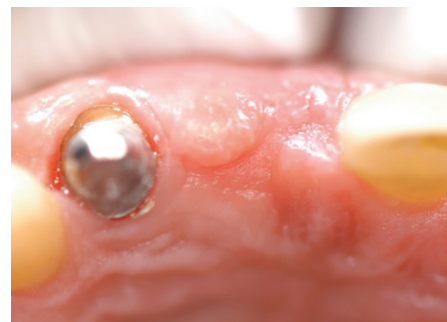
Figure 7: Healed soft tissue occlusal view

The volume of the soft tissue is preserved (Figure 7) with healthy papillae. This, combined with the shape of the crestal bone, provided an ideal environment for implant placement and encouraged a highly aesthetic and functional result.

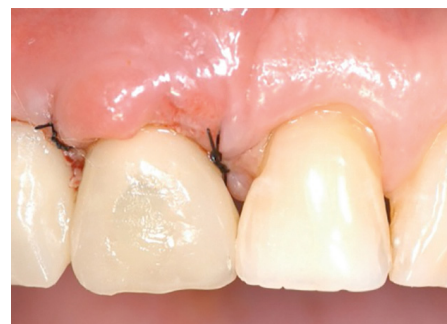
Figure 9: Soft tissue healing, one week after implant placement

At a review one week post implant placement, the soft tissue appeared to be healing well (Figure 9).

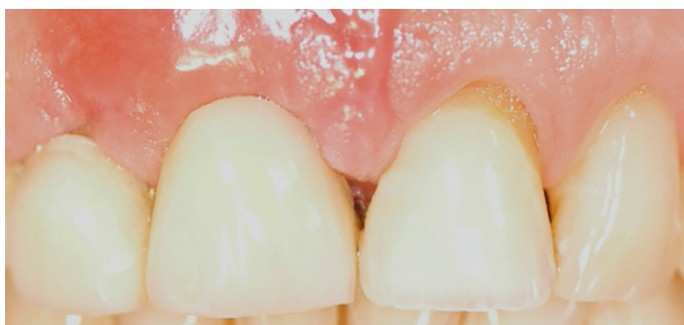
Figure 10: Two months after implant placement

Two months later, the soft tissues had healed as planned (Figure 10). It was still possible to see where the flap was raised, as the gingiva was more red in colour and more vascularised, but these would change with maturation to match the surrounding tissue.

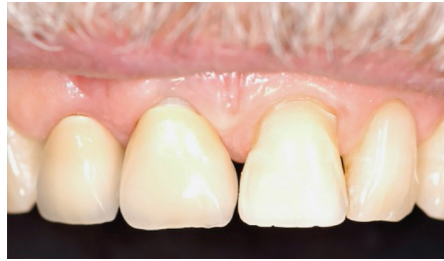
Figure 13: Post treatment

The final restoration was fitted onto a TBR zirconia abutment, which was placed in the mouth. The high quality and integrity of soft tissue was evident by the lack of inflammation.

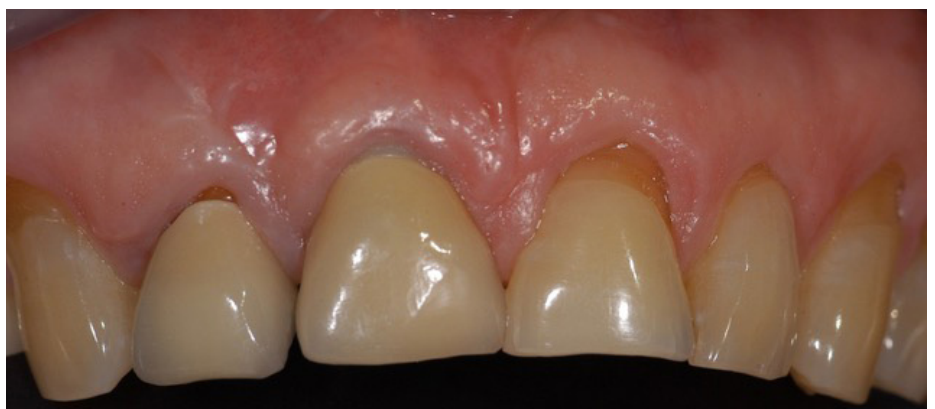
Figure 19: At the nine-year follow up the papillae has grown to reduce the amount of visible zirconia

In time, the biological behaviour of the transgingival portion of the implant is improved and we would therefore expect to see the papillae naturally grow to reduce the visible amount of zirconia.

This can be seen in the nine-year follow of this case outlined (Figure 19) showing once again the benefits of the Z1 zirconia collar implant from TBR.
